NEW YORK STATE
DEPARTMENT OF TRANSPORTATION

GEOTECHNICAL UPDATE REPORT SR 443 Delaware Avenue Landslide Elsmere, New York

**GEOTECHNICAL UPDATE REPORT
SR 443 LANDSLIDE
ELSMERE, NEW YORK**

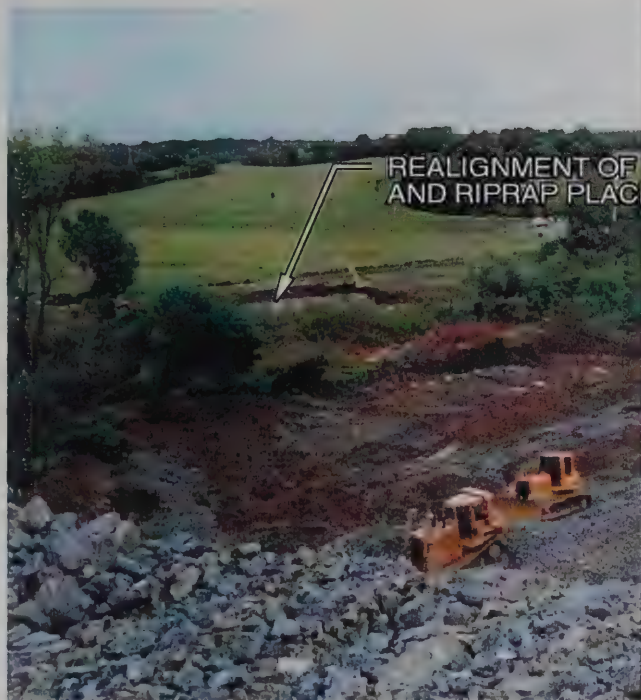
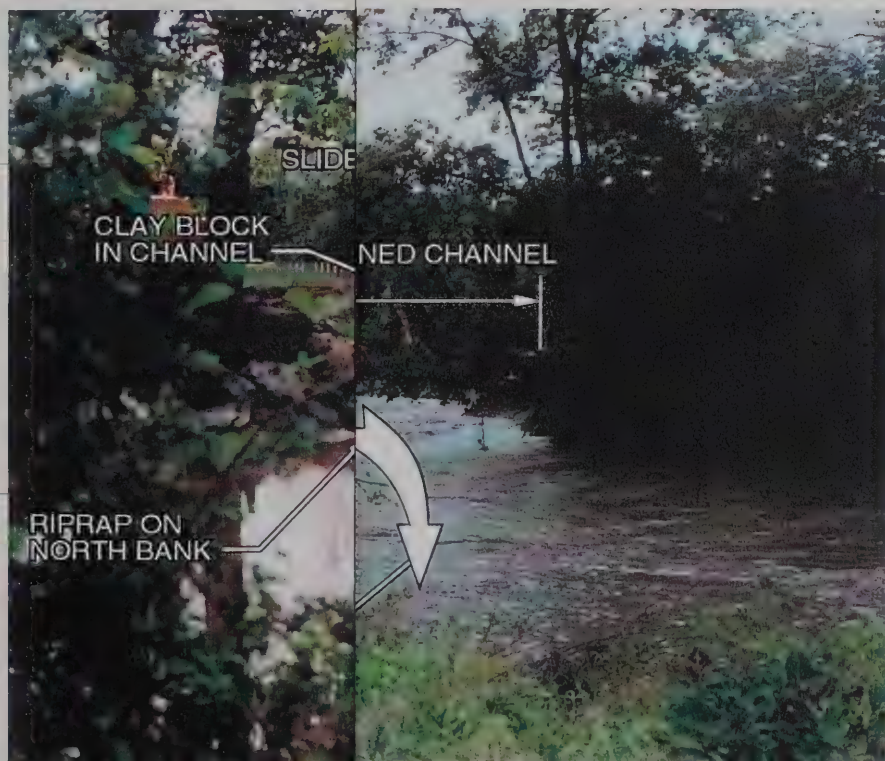
Landslide Technology 10250 S.W. Greenburg Rd. Portland, OR 97223	TITLE		PHOTOS	1280\UPDATE\FIGURE01 LJW
			JUNE 15, 2000	DATE JUN 2000
	JOB		SR 443 DELAWARE AVE. LANDSLIDE	JOB NO. 1280
			ELSMERE, NEW YORK	FIG. 1

1. We performed a geotechnical reconnaissance of the enlarged slide area on June 15, 2000. The landslide headscarp, toe, and sidescarps were traversed. Also, the slope to the east of the slide was walked to look for slide features. The main landslide had enlarged to the east about 20 to 40 feet, where new slumps were evident. This area had been identified in our previous reconnaissance as being marginally stable, with tension cracks extending east from the main slide sidescarp and several slump blocks in a partial state of collapse. Figure 1 presents photos showing some of the new slide features.

8. The City of Albany's contractor was removing slide debris from the stream channel and was placing additional riprap. The stream channel alignment was irregular because of slumped and eroded materials from the toe of the slide, and from excavations for new riprap, which extended further north midway along the slide-impacted section of stream bank. Photos of the stream channel conditions are shown on Figure 1.
